SUPERFUND FIVE YEAR REVIEW REPORT

LEE'S LANE LANDFILL

LOUISVILLE, JEFFERSON COUNTY, KY

JUNE 2003

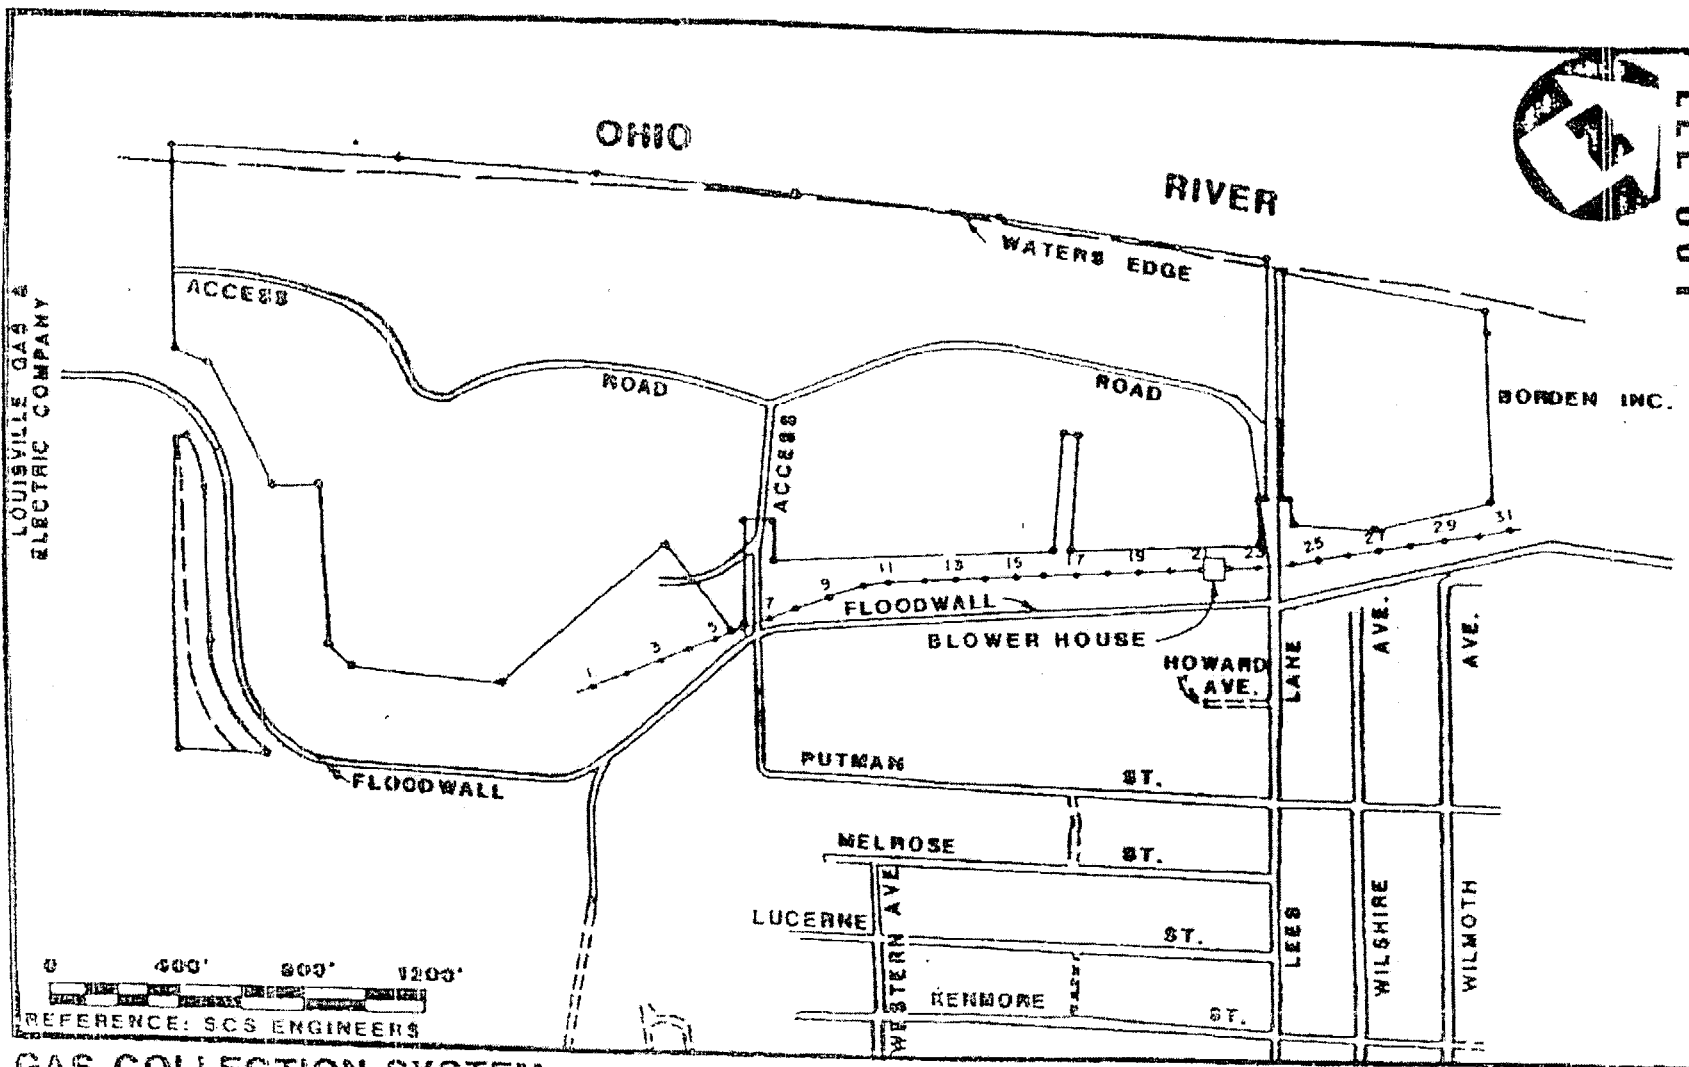
Figure 5
Subsurface Gas Collection System
Lee's Lane Landfill

16. The blower house for the subsurface gas collection system has many pipes and controls. Mr. Mike Humphrey of MSD indicated that the only maintenance that MSD performs is to replace burnt-out motors. The system runs continuously. He said MSD has no operations and maintenance manual for the system, no as-built drawings, and generally has no way of adequately monitoring the performance of the system, see Photographs 4 and 17, and Figure 5.
